# AN ASSESSMENT OF FLOOD DAMAGE IN NORTH CAROLINA USING A HIGH-RESOLUTION DIGITAL AIRBORNE IMAGING SYSTEM

**KEY WORDS: Remote sensing, hyperspectral imaging, hurricane Floyd, water quality.**

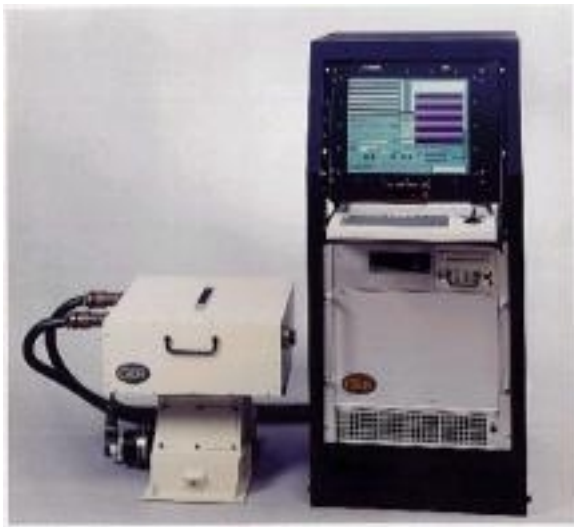
Figure 2 GER Optical Scanner

The components of the hyperspectral imager used during the flight campaign are shown in Figure 2. The sensor unit (to the left of the picture) contains the scanner and the spectrometer. The scanner defines the spatial characteristics of the acquired image while the spectrometer divides the energy from a pixel on the ground into its spectral components and transforms that

energy into an electronic signal. The scanner module is a "whisk broom" strip mapper. The optical scanner is based on the Kennedy Scanner, which consists of a multi-faceted rotating mirror. As the mirror rotates, the field of view changes and data are acquired across the aircraft flight track to form a scan line. Scan lines are accumulated along the flight track and a strip map image is produced. The spectrometer module is composed of different optical paths and provides many channels of spectral information depending on the specific design. The scanner deployed in North Carolina recorded 31 channels, in the visible, short wave infrared and thermal infrared, at resolutions up to 1-meter, or 11 bands at up to 0.5-meter resolution. All channels of the GER spectrometer are fully co-registered assuring accurate measurement of spectra within each individual pixel. The user operates the system via a simple graphical interface. System status may be monitored, real-time image data displayed, and system parameters set from a simple menu driven user interface. The software can also be used for mission playback.

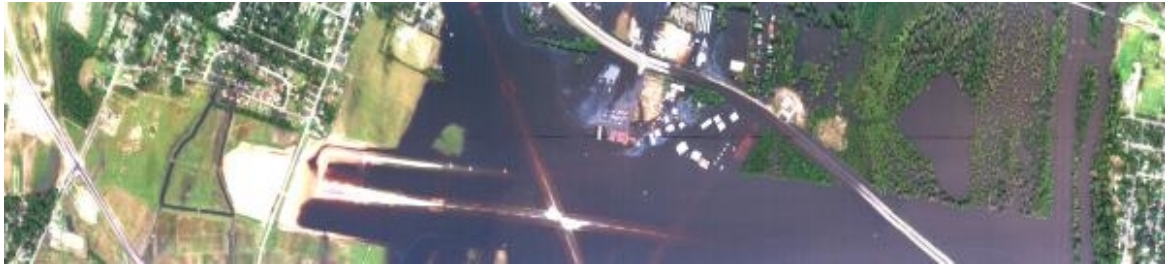
Figure 3, an image of flooded Greenville airport, shows a number of light aircraft either totally or partially submerged. The high resolution of the GER scanner is evident by the clearly defined runway markings visible through the floodwater.

Figure 3 High-Resolution, True-Color Image Of Flooded Airport
